The Skyco Water Treatment Plant – Anion Vessel Evaluation

County of Dare Water Department

Black & Veatch Project No. 161371

August 28, 2008

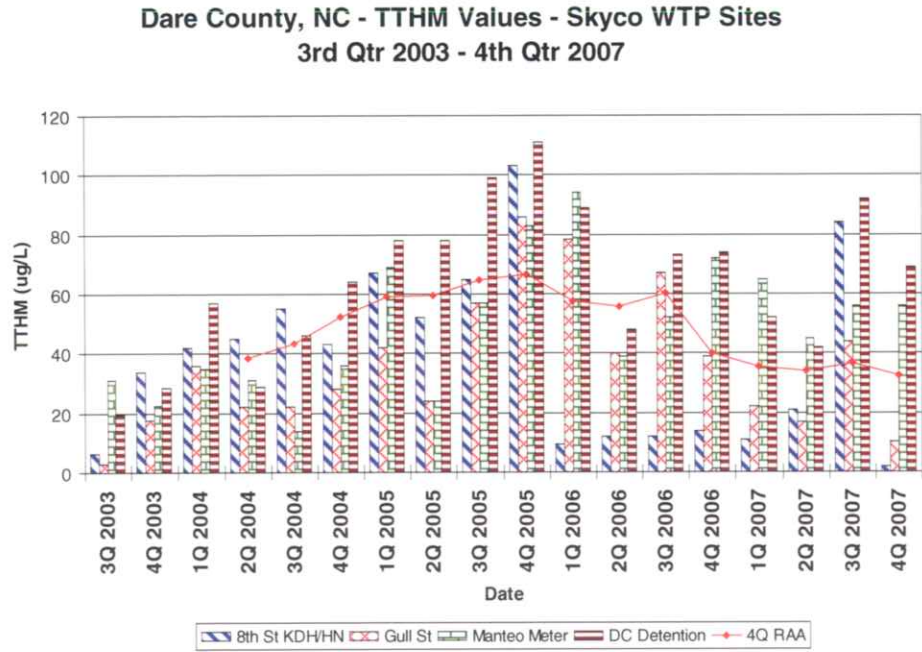
Figure 2-1 - TTHM Values – Skyco WTP Sites

According to the available data and information provided by the plant staff, the anion exchange system did reduce TTHMs during the first few years of operation; however, the TTHMs increased in 2005. They have declined somewhat since that time, but are still higher than pre-2004 levels. Figure 2-1 and Figure 2-2 summarize some of the historical TTHM and HAA5 information available, respectively, between 2003 and 2007. It should be noted that HAA5 levels are extremely low relative to the regulatory limits and do not appear to be an issue for the Skyco WTP. Figure 2-3 and Figure 2-4 summarize the locational running annual averages (LRAA's) for the TTHM and HAA5 levels from the Skyco WTP, which are the actual regulatory basis for compliance (80 ug/L for TTHMs and 60 ug/L for HAA5s).

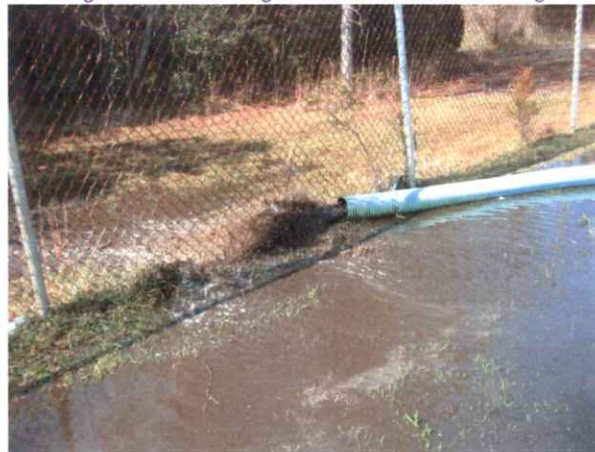
Figure 3-1 - Drainage from Clearwell Cleaning

As shown in Figure 3-1 and Figure 3-2, a large amount of organic debris was removed from the clearwell drain line when the clearwell was drained and cleaned during the course of the study. This could have been a factor that affected the level of DBP's leaving the facility, especially considering the high chlorine demand historically realized across the clearwell in relation to a relatively low TOC that entered the clearwell. Initial DBP sampling after the clearwell was drained and the debris removed was promising as the TTHMs leaving the WTP were less than 5 ug/L based on the laboratory analysis; However, subsequent compliance sampling results are still pending as those initial results appear somewhat questionable. In any case, the removal of that debris from the clearwell should reduce the chlorine demand historically realized through the clearwell, subsequently reducing the THM formation to some degree in the distribution system.

- A large amount of chlorine decay historically had occurred through the clearwell. The removal of a large amount of debris from the clearwell drain line may reduce DBP formation in the future.

Since the debris had been removed from the clearwell, the chlorine demand across the clearwell may be reduced and this may reduce chlorine costs to some extent. Additionally, it should reduce the DBP formation as well. However, since the TOC removal across the resin is still less than optimal, there may be issues with TTHM levels in the distribution system. Careful monitoring will be required as well as regular future maintenance of the clearwell to ensure that debris does not build up in the future.

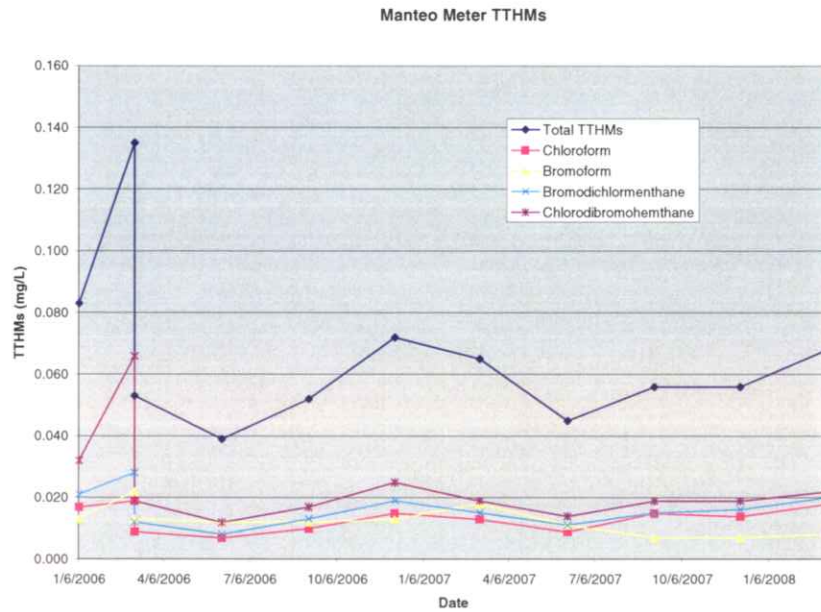
Figure 4-1 – TTHM Fractional Breakdown – Manteo Meter

Bromide seems to be a major component of the TTHMs that are being formed. As shown in Figure 4-1 and Figure 4-2, the bromide portion of the TTHMs in the finished water is a large portion of the total. In addition, as shown in Figure 4-3 and Figure 4-4, this is also the case with the HAA5s, although the total concentration of HAA5s don't seem to be as major of a concern. Bromide is an issue in terms of DBP formation as it is relatively heavy in terms of ug/L as compared to the chlorinated fractions of DBP. Therefore, a small amount of bromide can result in relatively large amounts of DBPs.

The bromide at the Skyco WTP is likely to be from one of two sources. First, the raw water could have bromide present. The County does not regularly test for bromide in the well supply. Based on a single sample taken during this study, the bromide appears to be less than 0.5 mg/L, which was the detection limit for the laboratory conducting the analyses. However, this is too high of a detection limit considering the levels found in the DBPs. It is recommended that bromide testing be performed with a new laboratory that has detection limits of 0.05 mg/L or less.

The other potential source is bromide that may be present in the salt used for the brine regenerant. Solar (or sea) salt, which is the most common and cost effective salt available, can contain levels of bromide. Rock salt, which can be significantly more expensive does not have bromide present. Therefore, if no bromide is found in the raw water, yet brominated DBPs are still being formed, the County could consider switching to a rock-based salt for the regenerant; however, the high cost for lower bromide salt may affect this decision.

The County should request the bromide content of the salt from the current supplier. Another way to help determine if the salt is a culprit may be to compare the DBP formation of brominated DBPs at the Frisco WTP, which one would assume utilizes the same salt for a regenerant.

5. Add VFDs with SCADA control on all Skyco WTP well pumps to provide turndown when softener vessels enter a backwash.
6. Evaluate salt utilized for brine regenerant for the presence of bromide. Utilize a different salt if appropriate and cost effective.

7. Increase raw water bromide sampling frequency and have analysis conducted with a detection limit of 0.05 mg/L.
