# 2022 Buxton Beach Renourishment

Project Update — July 15, 2022

Issue No. 1

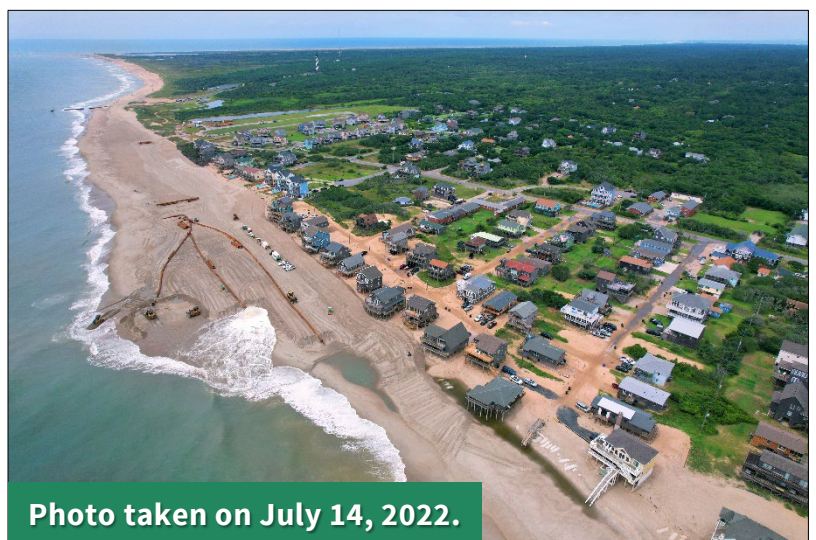
Photo taken on July 14, 2022.

The Buxton beach renourishment project officially commenced on **Thursday, June 30, 2022**. As of Friday, July 15, the contractor, Great Lakes Dredge & Dock Company (GLDD), has placed approximately 300,000 cubic yards (cy) of sand along the Buxton oceanfront, equivalent to 25% of the total project volume. Approximately 2,500 feet (ft) of the beach from Tower Circle to the ocean groin field near the original location of the Cape Hatteras Lighthouse has received nourishment sand. Pumping is currently proceeding north.

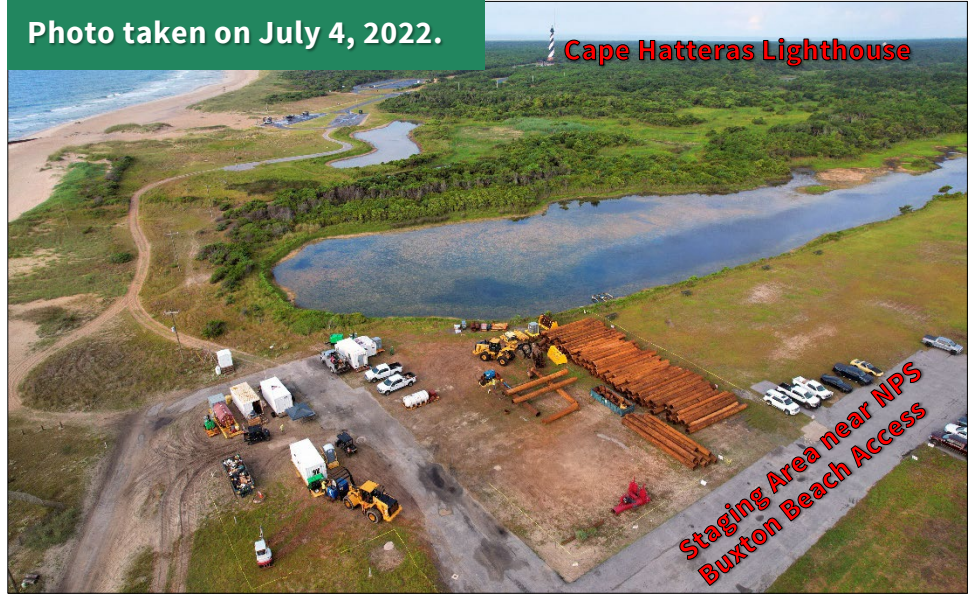
Photo taken on July 4, 2022.

before coming down to Buxton. The dredge's first load was delivered in Buxton on the afternoon of June 30 near Cape Court. Before the dredge's arrival, a submerged pipeline had already been installed on the beach in that locality. Pumping proceeded south for the following 11 days, and construction reached the southernmost boundary of the Buxton project on Monday, July 11. Sand ramps over the shore pipes were built every 200 to 300 ft along the complete sections. The public used these ramps when crossing the shore pipes.

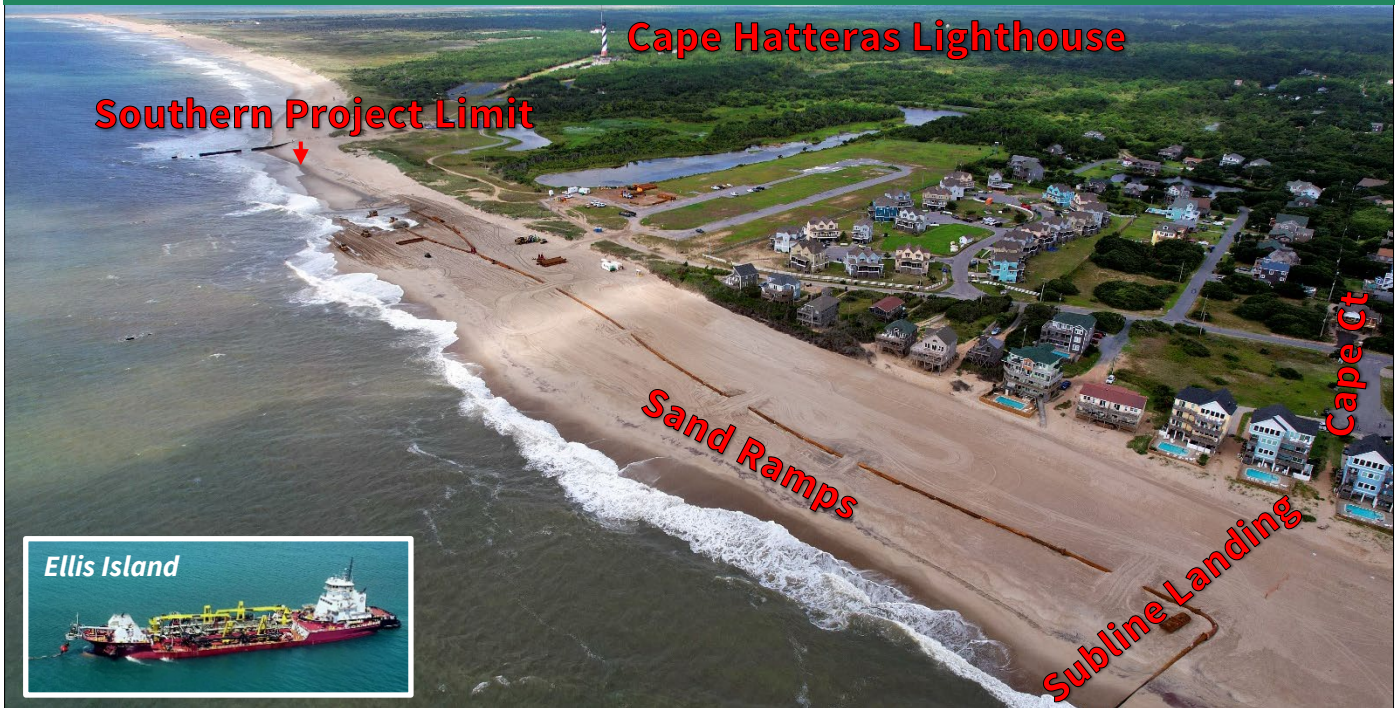
Pumping approaching the southernmost project boundary on Monday morning, July 11, 2022.

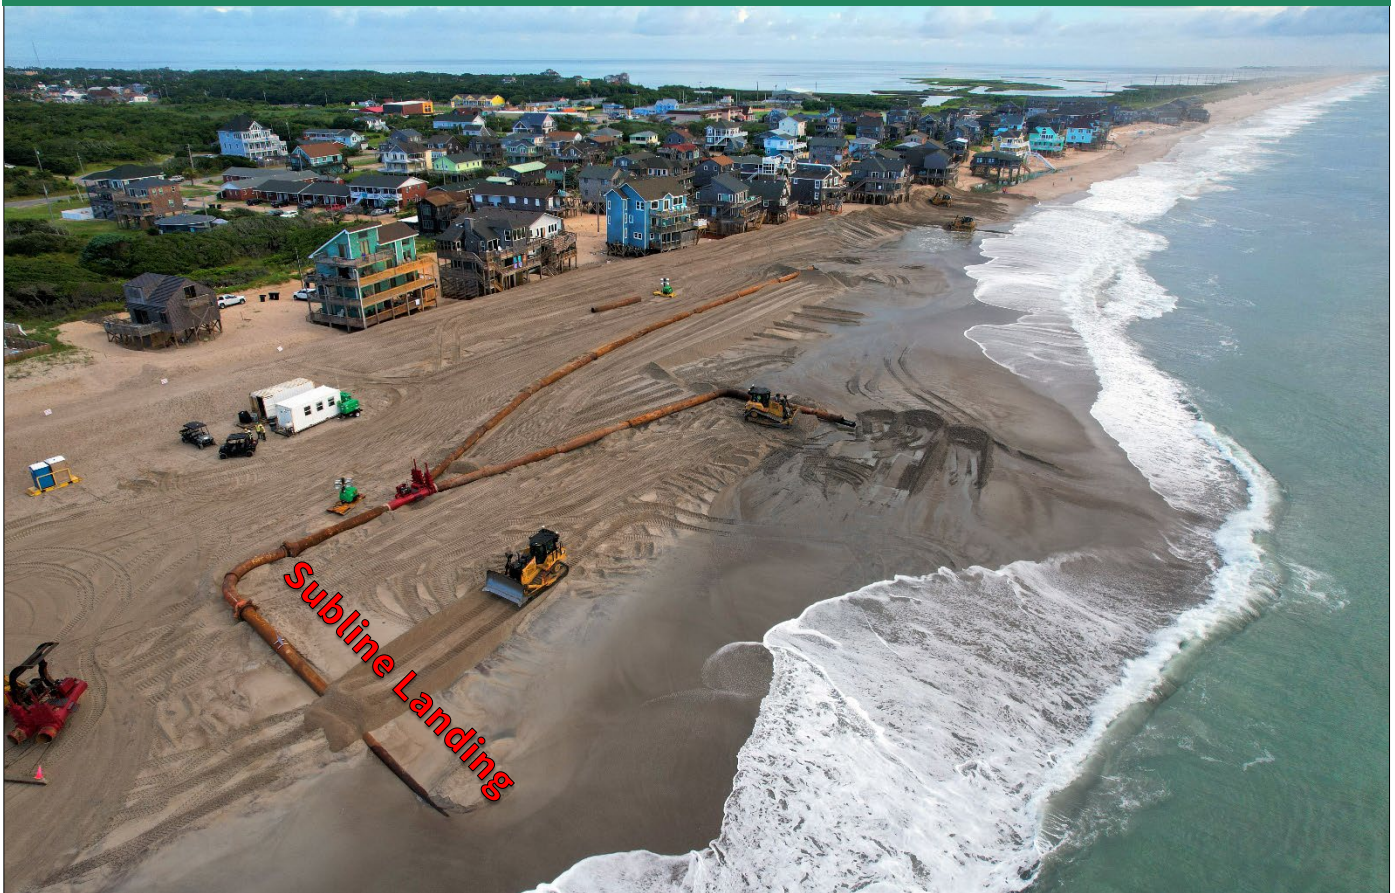
After the southern section of the project area was completed, shore pipes were removed, and the newly nourished beach was graded and completely opened to the public on the morning of Tuesday, July 12. That afternoon, nourishment operations returned to the area near the subline landing point, and the pumping direction moved north toward the northern limit of the Village of Buxton.

**Construction started proceeding north toward the National Seashore. [Photo July 12, 2022]**

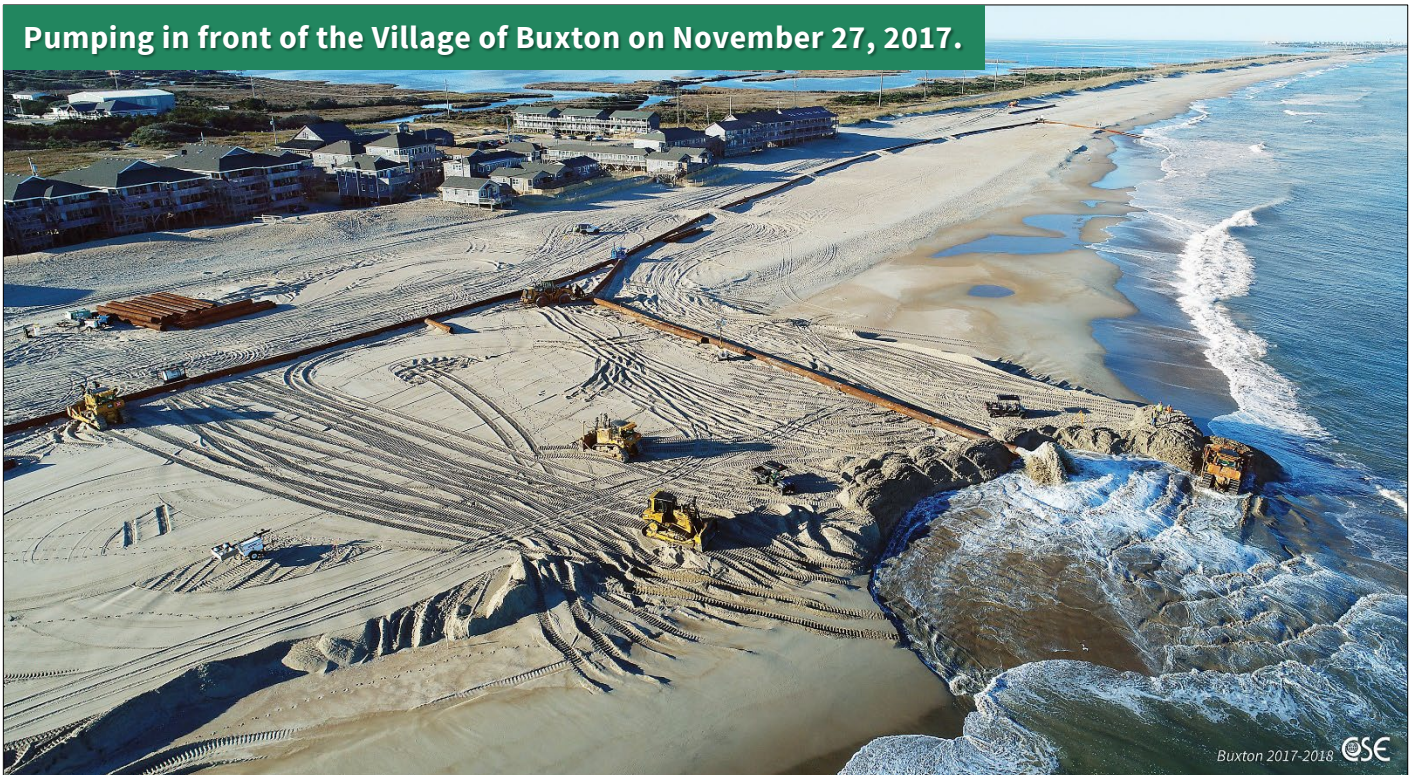
**Pumping in front of the Village of Buxton on November 27, 2017.**

Summer dredging was permitted for beach nourishment projects in the Outer Banks because of inclement wave conditions in the winter months. The contractor, Weeks Marine, elected to use a cutterhead dredge to start the nourishment on June 21, 2017. Construction lagged primarily due to rough sea conditions that frequently curtailed operations and led to mechanical breakdowns. Four named hurricanes (*Irma*, *Jose*, *Katia*, and *Maria*) impacted the project area in September 2017, producing wave heights significantly higher than the required safe operating conditions for a cutterhead dredge. The contractor started using a hopper dredge to continue the project in October 2017. Despite the intermittent work schedule, construction moved forward. As of December 22, 2017, nourishment in front of the narrow isthmus of N.C. Highway 12 was completed, and a highly vulnerable section of the road was protected.

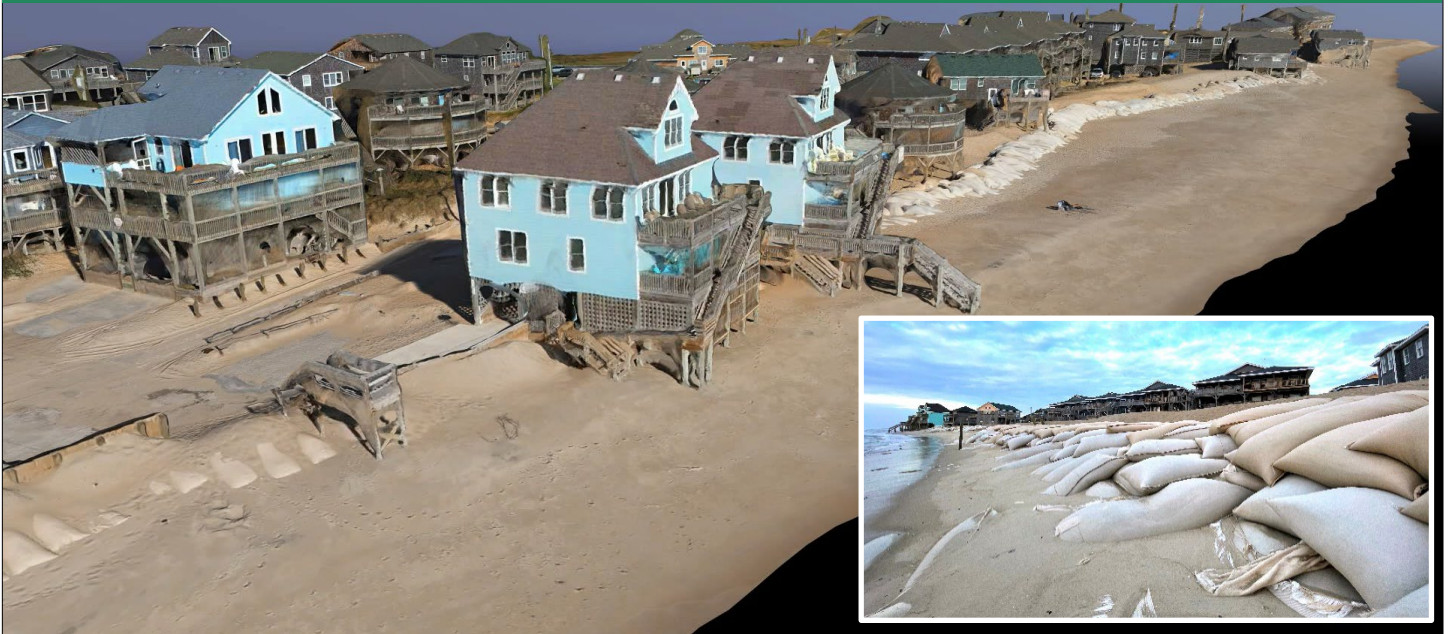
**Orthophotography mosaic generated on March 25, 2022 during low tide showing little dry-sand beach and exposed sand bags on the oceanfront.**

After project completion, the newly nourished beach withstood a series of nor'easters in March 2018. It also endured Hurricane *Florence* in September 2018, Hurricane *Dorian* in September 2019, and other winter storms without much interruption to N.C. Highway 12 traffic or damage to the Buxton oceanfront properties. However, nourishment sand was lost outside of the project area after each weather event since project completion, and Buxton returned to pre-nourishment conditions before the 2022 renourishment project was implemented. Some sand bags were exposed due to erosion, and property owners installed new sand bags as a temporary shoreline protection measure. The loss of dry beach made N.C. Highway 12 vulnerable to flooding and breaching once again.
