The Skyco Water Treatment Plant – Anion Vessel Evaluation

County of Dare Water Department

Black & Veatch Project No. 161371

August 28, 2008

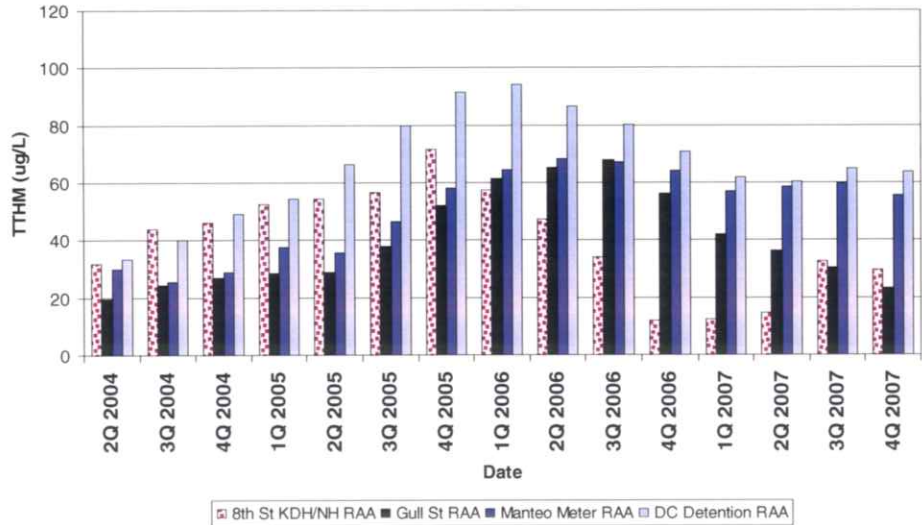
Figure 2-3 - TTHM LRAA Values – Skyco WTP Sites

According to the available data and information provided by the plant staff, the anion exchange system did reduce TTHMs during the first few years of operation; however, the TTHMs increased in 2005. They have declined somewhat since that time, but are still higher than pre-2004 levels. Figure 2-1 and Figure 2-2 summarize some of the historical TTHM and HAA5 information available, respectively, between 2003 and 2007. It should be noted that HAA5 levels are extremely low relative to the regulatory limits and do not appear to be an issue for the Skyco WTP. Figure 2-3 and Figure 2-4 summarize the locational running annual averages (LRAA's) for the TTHM and HAA5 levels from the Skyco WTP, which are the actual regulatory basis for compliance (80 ug/L for TTHMs and 60 ug/L for HAA5s).
